TexPro Residential & Commercial Inspections

Property Inspection Report #TP000001tc

Concerning: **2345 WhatANice Drive Houston, TX 77000**
(Address or Other Identification of Inspected Property)

This inspection is of a 3 story single family residence, Brick / Cement Fiber board exterior, composition roof with an attached garage. For reference this property faces **West**.

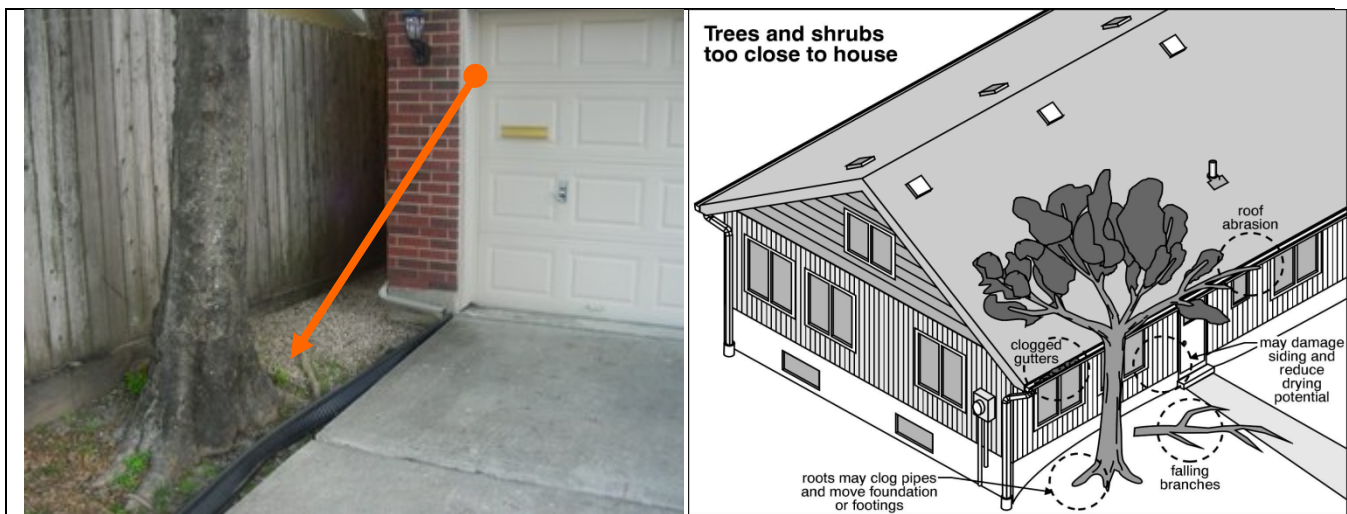
- Observed one or more trees near the house foundation. The client should consider removal of the tree(s) or the installation of root barriers to reduce the possibility of damage to the house foundation from tree roots and moisture removal.

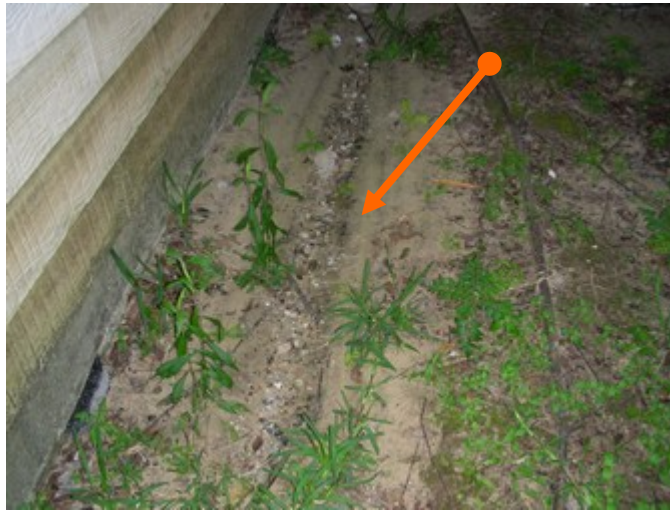
- Recommend the addition of rain gutters to help improve drainage and/or prevent erosion around the home.

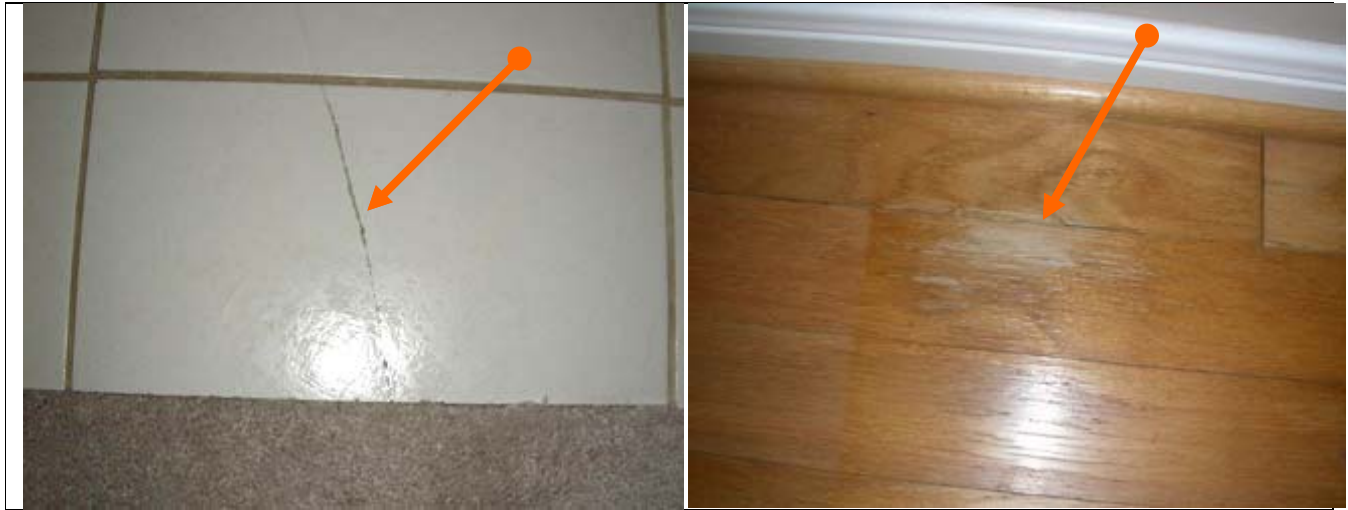
- Observed chipped, cracked and/or loose floor tile in one or more areas.
- Observed evidence of water penetration / stains / damaged wood flooring.

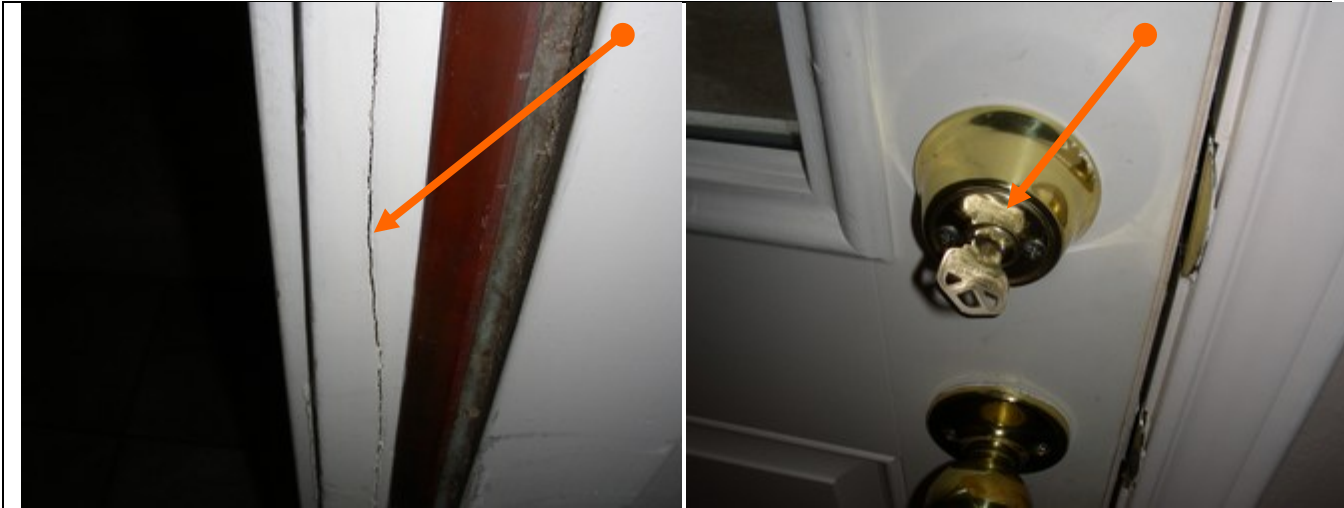
- Observed damage and/or holes in one or more exterior door jams.
- Observed one or more exterior doors do not have a thumb latch to unlock the door. Current code requires all egress doors to open from the inside without the use of a key or special knowledge or effort.

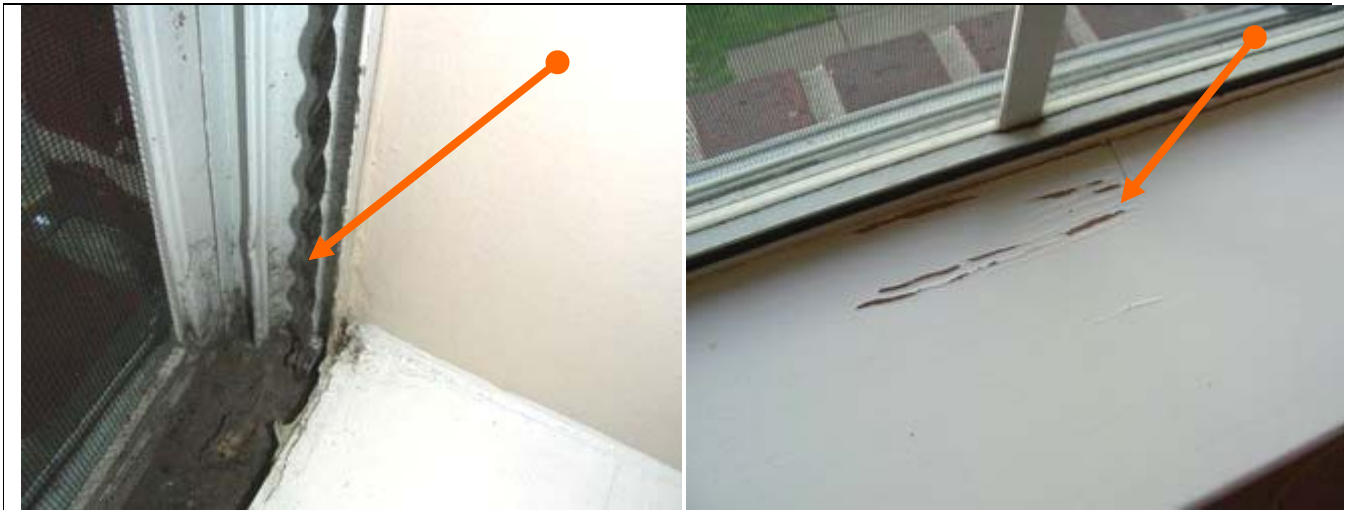
- One or more window spring(s) were observed to be sprung/broken.
- Observed one or more slightly damaged window sills.

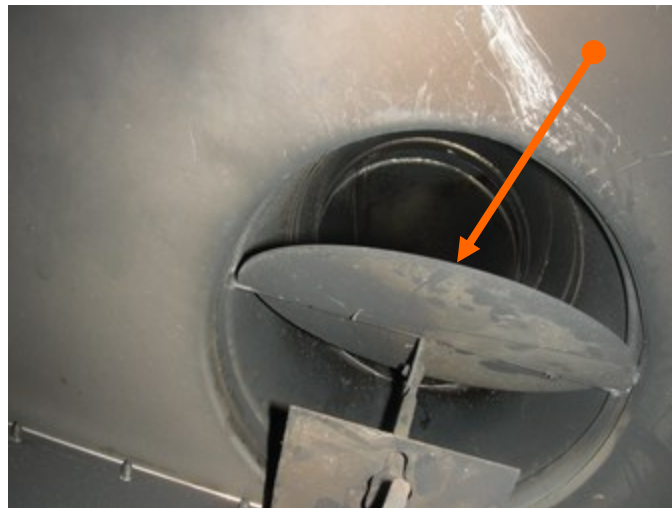
- Observed the fireplace damper clamps are missing. This clamp keeps the damper from fully closing when the fireplace is equipped with a gas appliance. If the damper is fully closed then combustion fumes/gas will enter the house unseen.

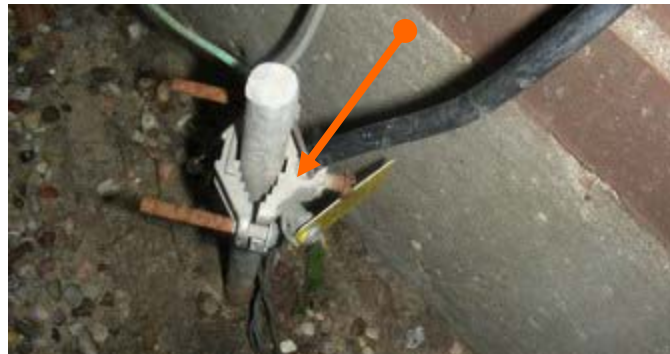
- **The main ground clamp and/or wire is not secured properly to the ground rod below the electrical service meter.**

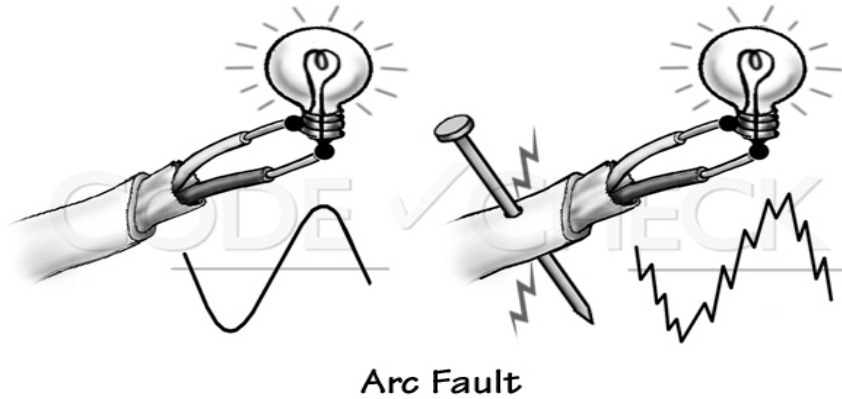
- **Arc fault circuit interrupters, which protect the living area switches, receptacles and fixtures, were not present at the time of the inspection. These are required to meet current code and safety standards.**

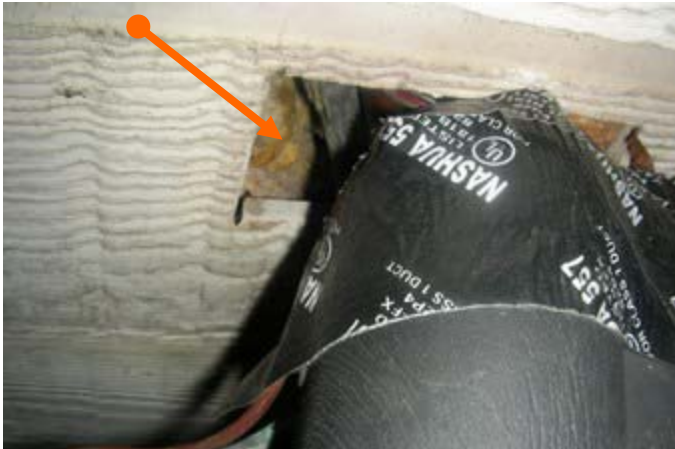
- Recommend sealing the exterior openings where the AC lines enter the house.

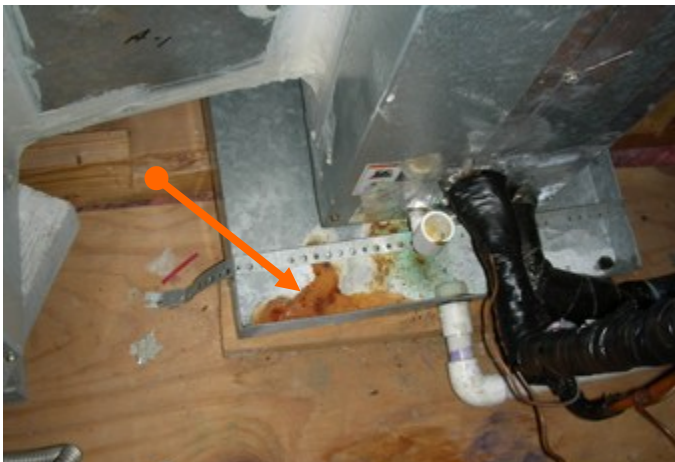
- Secondary drain pan has rust stains. This is an indication the coil (or previous coil) has a history of leaking/dripping condensation into the pan.

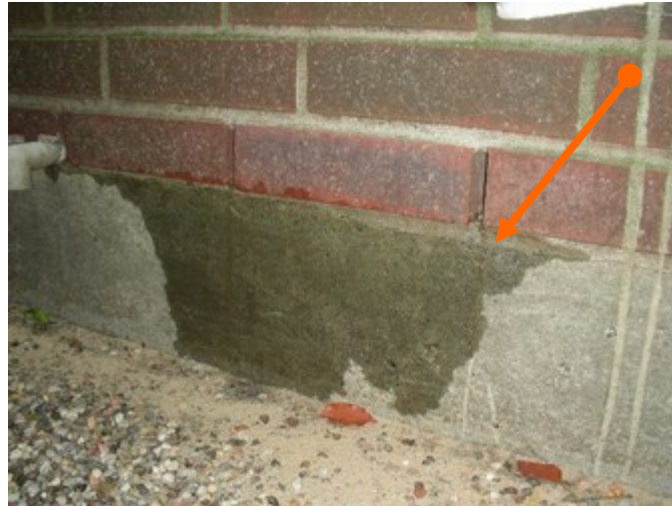
- **Observed water leaking under exterior wall, possibly from master bathroom above.**

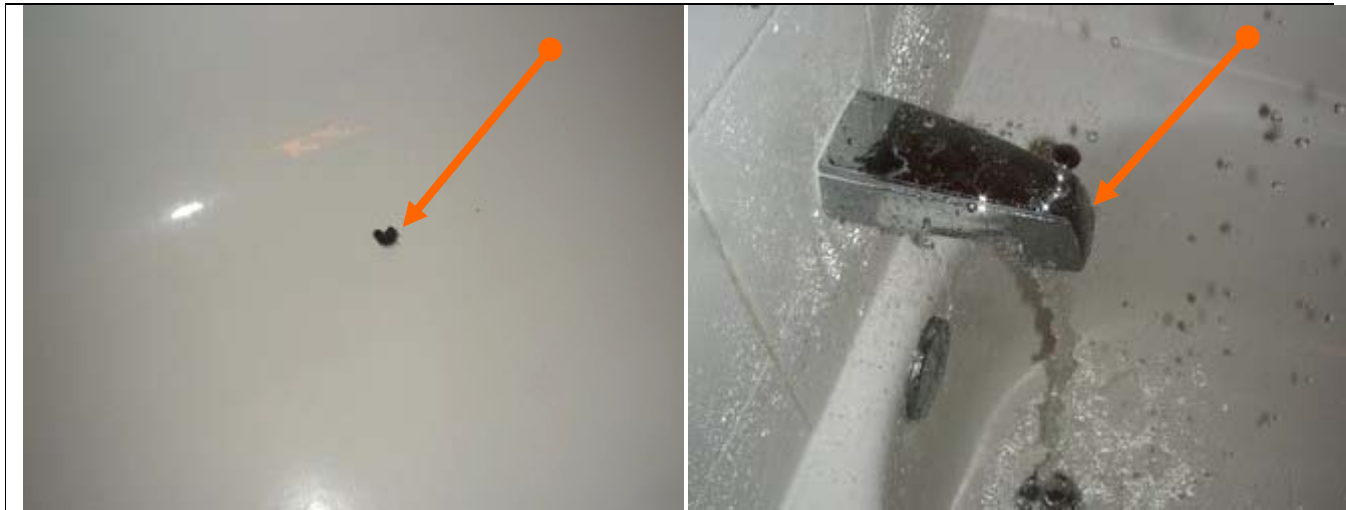
- Observed cracks, chips and/or pits in the tub and/or shower surround.
- Observed one or more shower diverter valve is not fully functional. The diverter does not direct all the water to the shower head during operation.

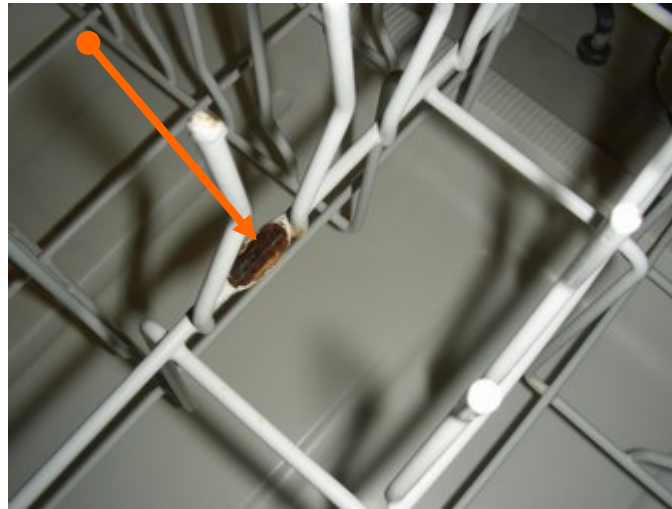
- Observed the dish rack(s) in the dishwasher is rusted and/or deteriorated in one or more places.
